# ADA TITLE II SELF-EVALUATION AND TRANSITION PLAN

## City of Chino

## ADA TITLE II SELF-EVALUATION AND TRANSITION PLAN

January 30, 2024

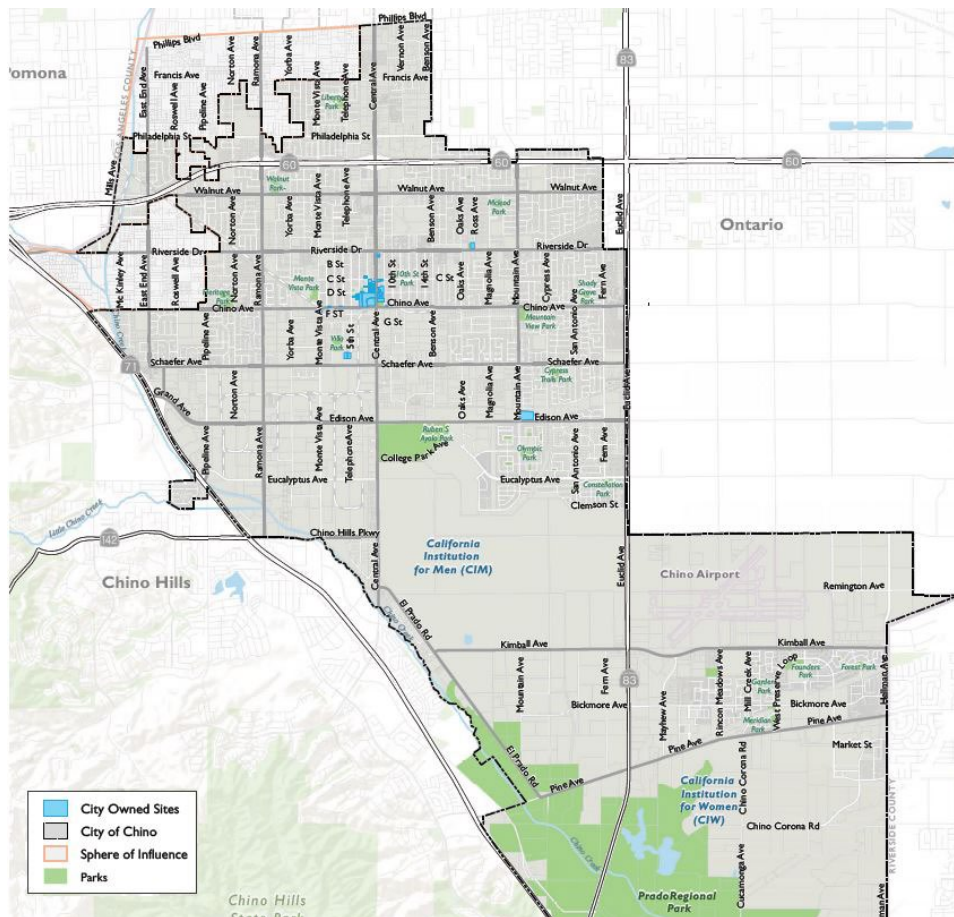
As part of the City of Chino’s effort to comply with Title II of the ADA, the City’s pedestrian facilities in the public right-of-way were evaluated for ADA compliance using the proposed PROWAG and applicable state and local accessibility regulations. 4,260 curb ramps, 85 transit stops, 844 pedestrian signals, and 369.59 miles of sidewalk were assessed for physical barriers to accessibility from April 2023 to August 2023. The figure below displays all areas evaluated as part of the City owned public right-of-way. The full sidewalk and curb ramp evaluation maps are provided in Appendix F.

Map View of City PROW Facility

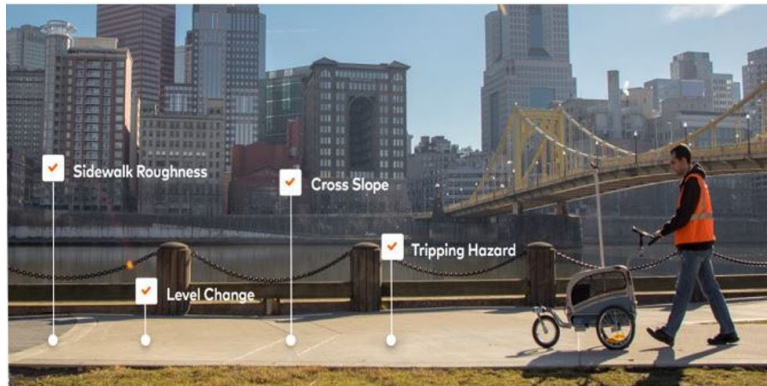
Sidewalk data was collected using pathVu's "pathMet" sidewalk profiler, which was developed for sidewalk ADA assessments. *pathMet* is a manually propelled, multi-sensor, stroller-type profiling tool. It uses GPS and high-resolution cameras, lasers, and sensors to measure ADA compliance of sidewalks including cross slope, running slope, surface roughness, clear width of sidewalks, protruding hazards, and level changes. Deviations from the required ADA standards and other applicable guidelines pertaining to PROW are identified using detailed information on slopes and surface variations. A comprehensive data set has been provided to the City for inclusion into the City's existing GIS system.

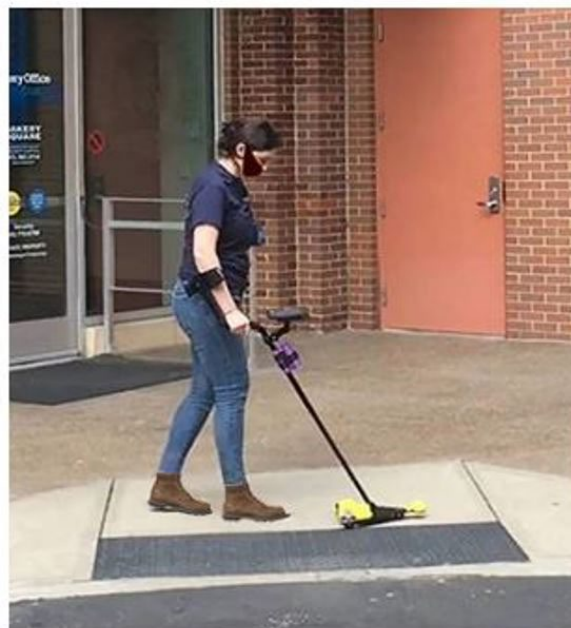
Curb ramps were assessed using pathVU's "curbMet" assessment tool. Data collected included: running slope, cross slope, width and length dimensions, flare information, the presence of detectable warnings, damages, obstructions, landing slopes, as well as several other attributes. The internal data collection checklist is based on ADA and the California Building Code requirements as well as the Public Right of Way Accessibility Guidelines (PROWAG) recommendations. A comprehensive data set has been provided to the City for inclusion into the City's existing GIS system.

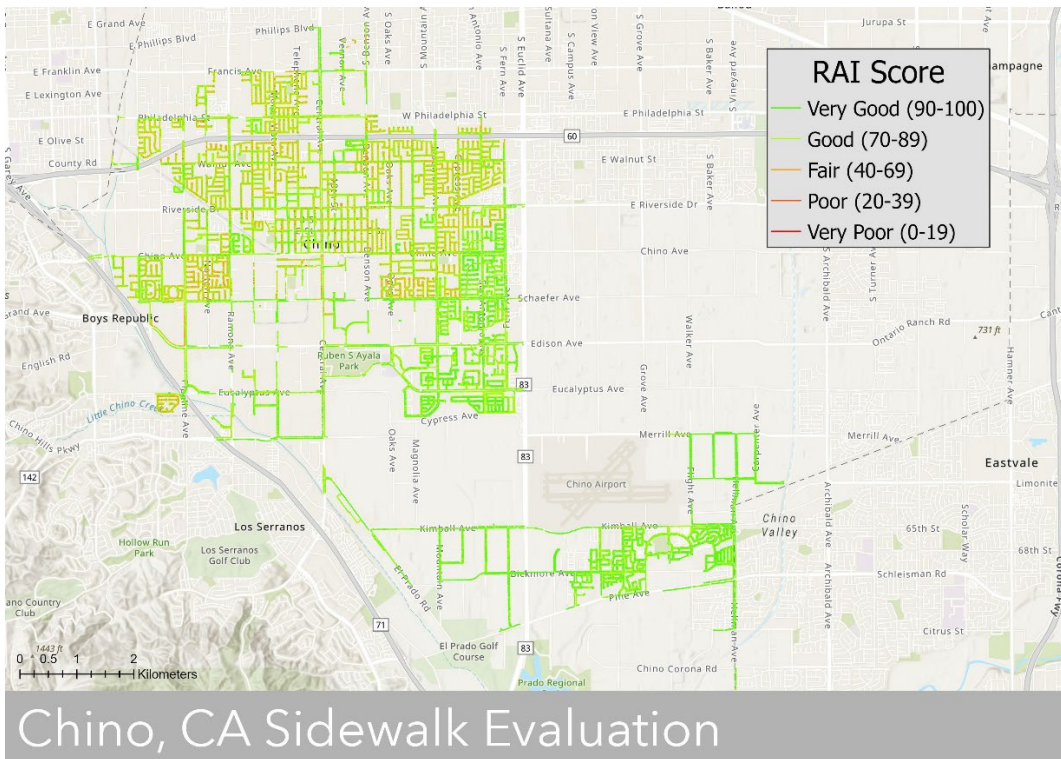
The data collected on this assessment was in continuous block runs of sidewalks. The data was captured into 10-foot run sections, so as not degrade an entire block for one 10 or 20 linear foot issue. Each 10-foot run segment provides an aggregated score of the roughness and the extreme value of vertical level changes, slope, or gap. The GIS data provided to the City is capable of being viewed in both ‘block-level’ runs and 10-foot run sections.

Overall GIS / Map View of Sidewalk Inventory

Based on the onsite review, Bureau Veritas found that barriers to accessibility exist within the city sidewalks. The observed elements were analyzed using the Access Board’s proposed Public Rights-of-Way Accessibility Guidelines (PROWAG) and the California Building Code.

- 369.59 miles of sidewalk were assessed
- 111.87 (30.27%) miles of sidewalk are nearly compliant or compliant
- 244.91 miles (35.71%) of sidewalk had cross slopes greater than the maximum of 2.08%
- 347 instances of sidewalk were identified with cracks and concrete deterioration.
- 34,136 instances where vertical change in level was greater than the allowable ¼”
- 251 instances where the vertical clearance was reduced to less than 80” by overhanging vegetation or other objects.
- 303 instances where overgrown vegetation reduced the sidewalk clear width to less than the minimum of 48”.
- 648 instances where utility pole, natural barrier, or other object reduces the sidewalk clear width to less than the minimum of 36” in the case where a 48” sidewalk cannot be achieved due to unreasonable hardship.

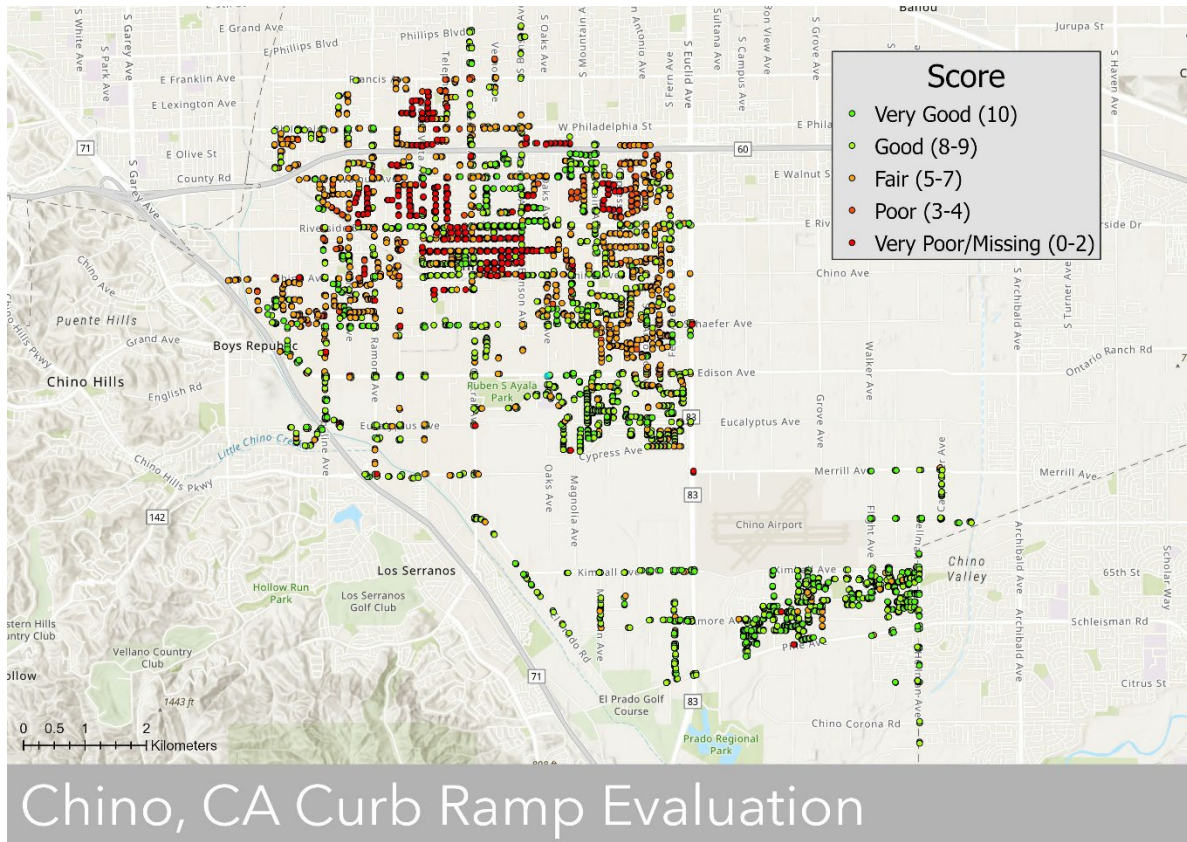
Based on the onsite review, Bureau Veritas found that barriers to accessibility exist within the City’s curb ramp inventory. The observed elements were analyzed using the Access Board’s proposed Public Rights-of-Way Accessibility Guidelines (PROWAG) and California Building Code (CBC).

Overall GIS / Map View of Curb Ramp Inventory

The following table summarizes the curb ramp barriers that were identified including remediation method and cost and their priorities base on their curb ramp score.

- 4,260 curb ramps were assessed.
- 902 (21.17%) curb ramps were nearly compliant or compliant .
- 891 (20.91%) curb ramps had running slopes greater than the maximum allowed of 8.33%.
- 1,184 (27.79%) curb ramps had cross slopes greater than the maximum allowed of 2.08%.
- 244 (5.73%) curb ramps had clear width less than the minimum of 48”.
- 1,648 (38.69%) curb ramps had top landing slopes exceeding the maximum of 2.08%.
- 1,075 (25.23%) curb ramps were missing detectable warnings.
- 479 instances where curb ramps were not provided where they were required.

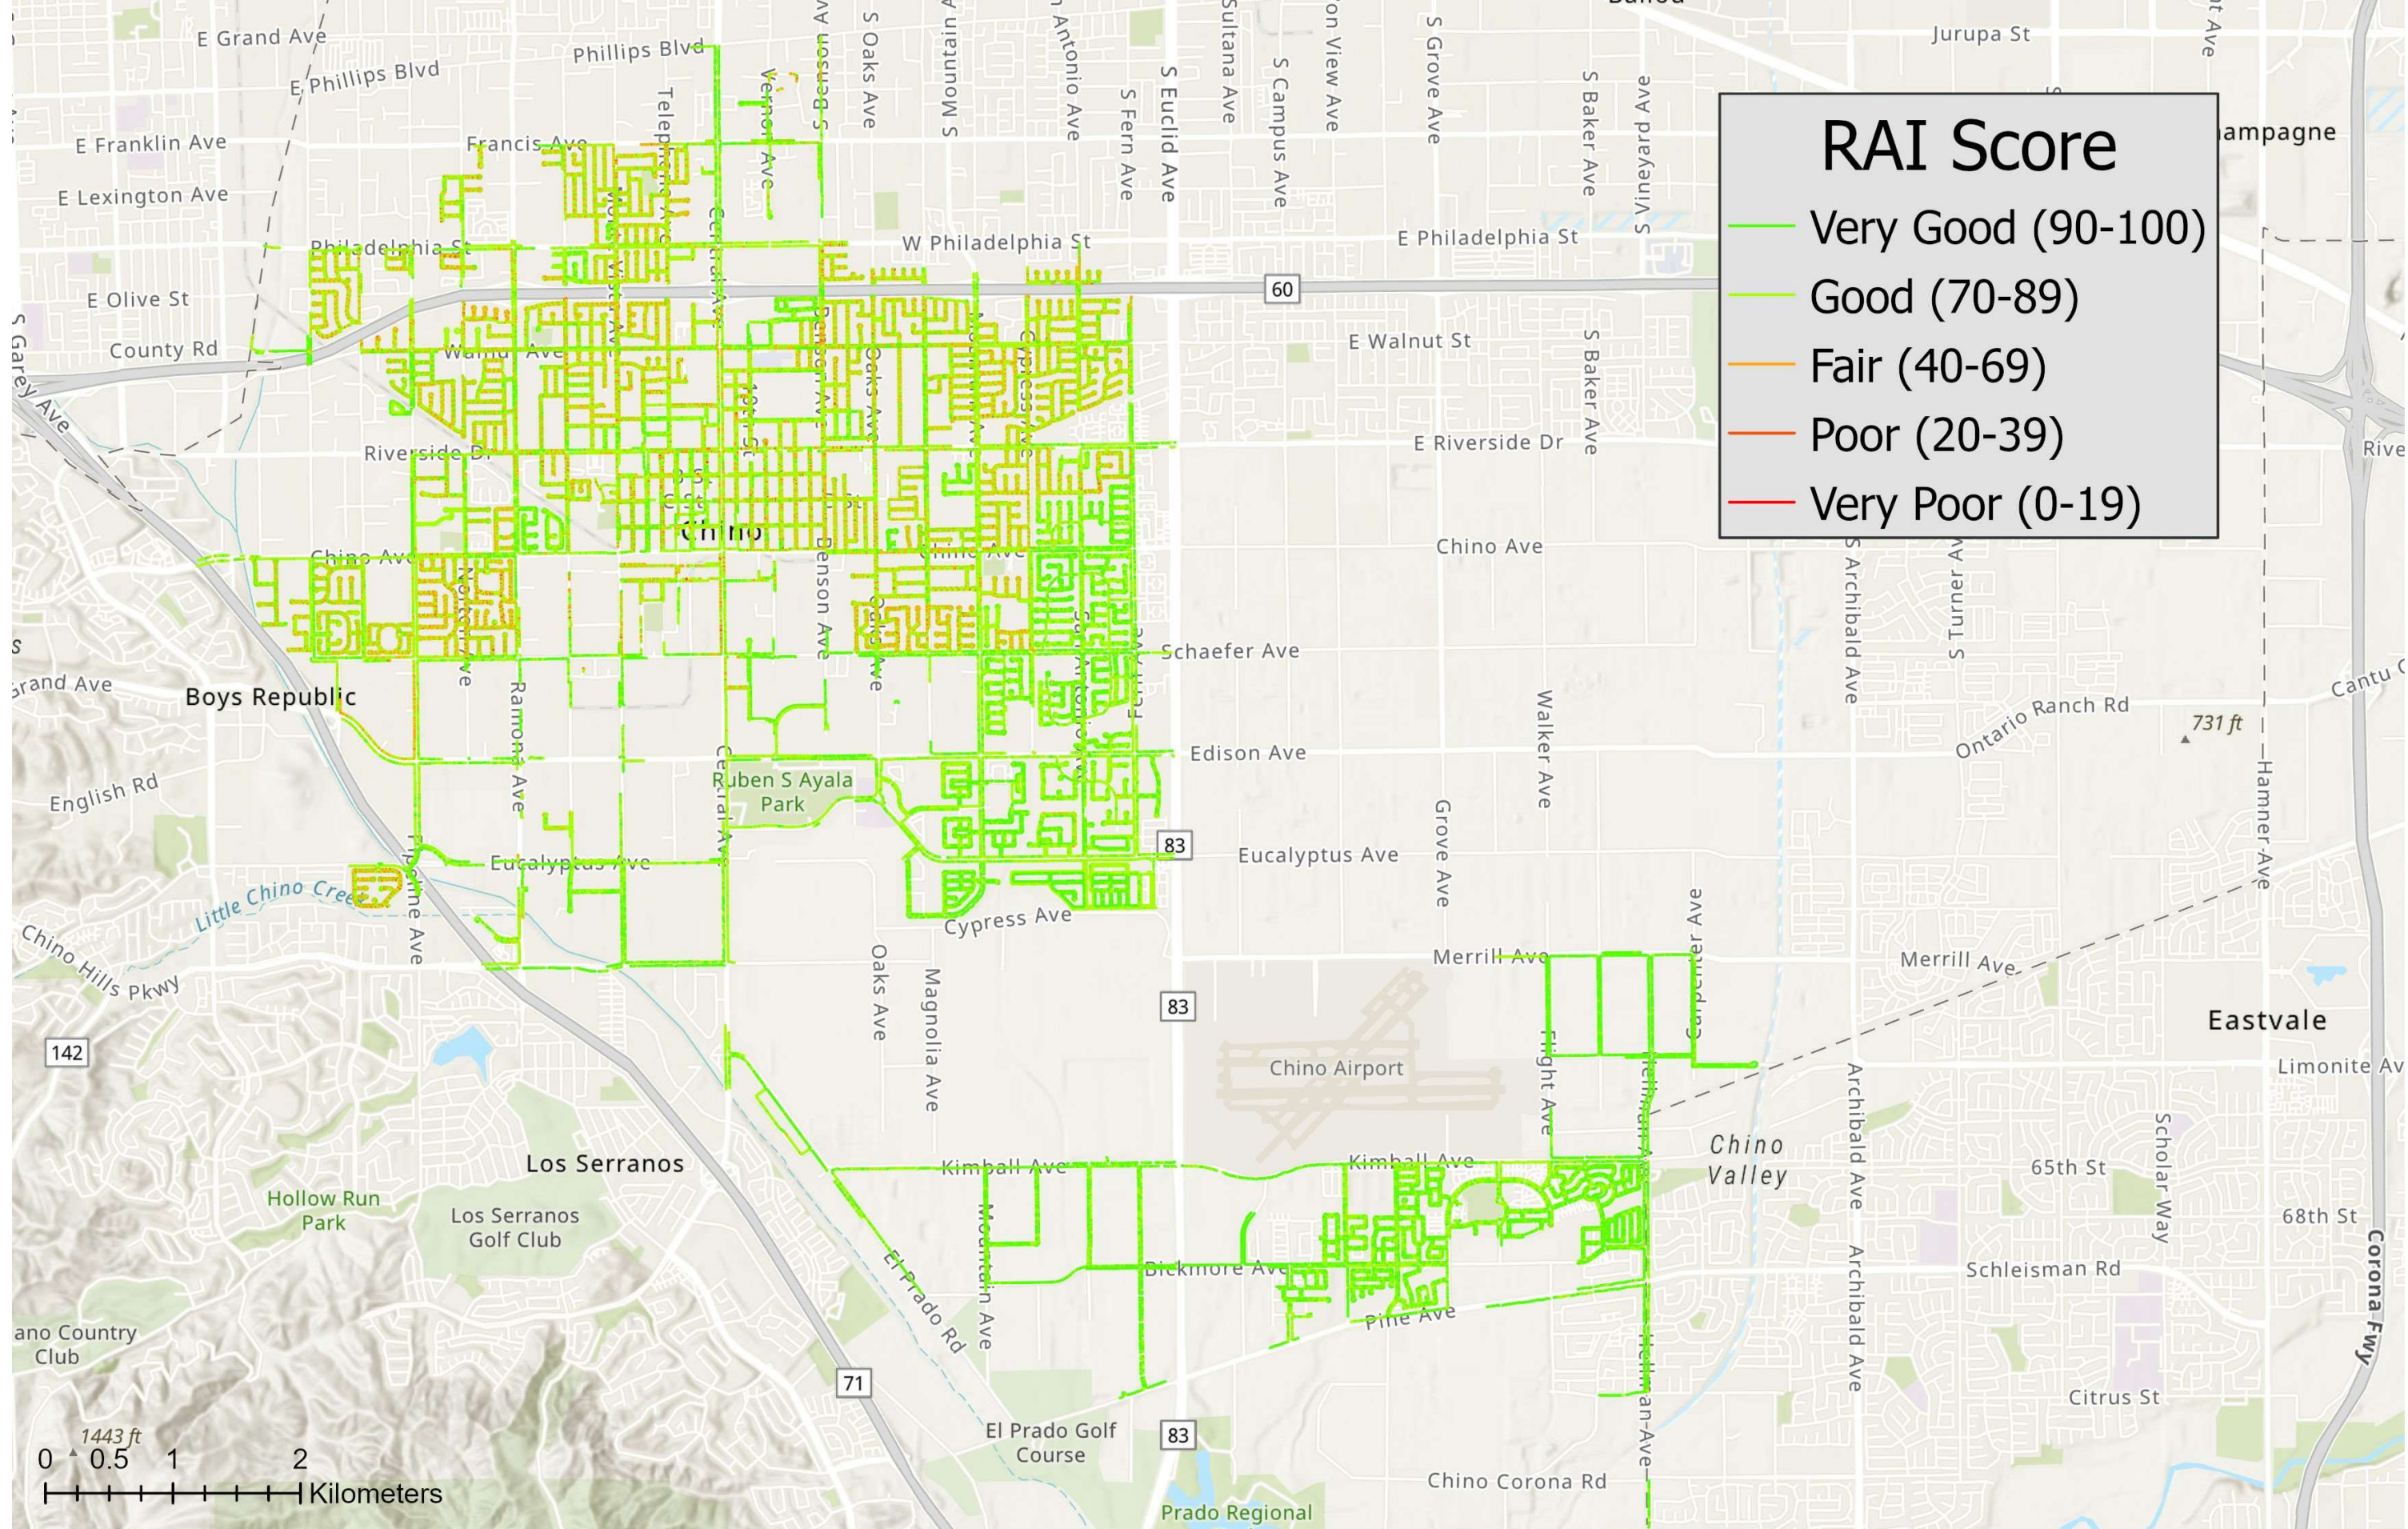
### RAI Score

- Very Good (90-100)
- Good (70-89)
- Fair (40-69)
- Poor (20-39)
- Very Poor (0-19)

# Chino, CA Sidewalk Evaluation

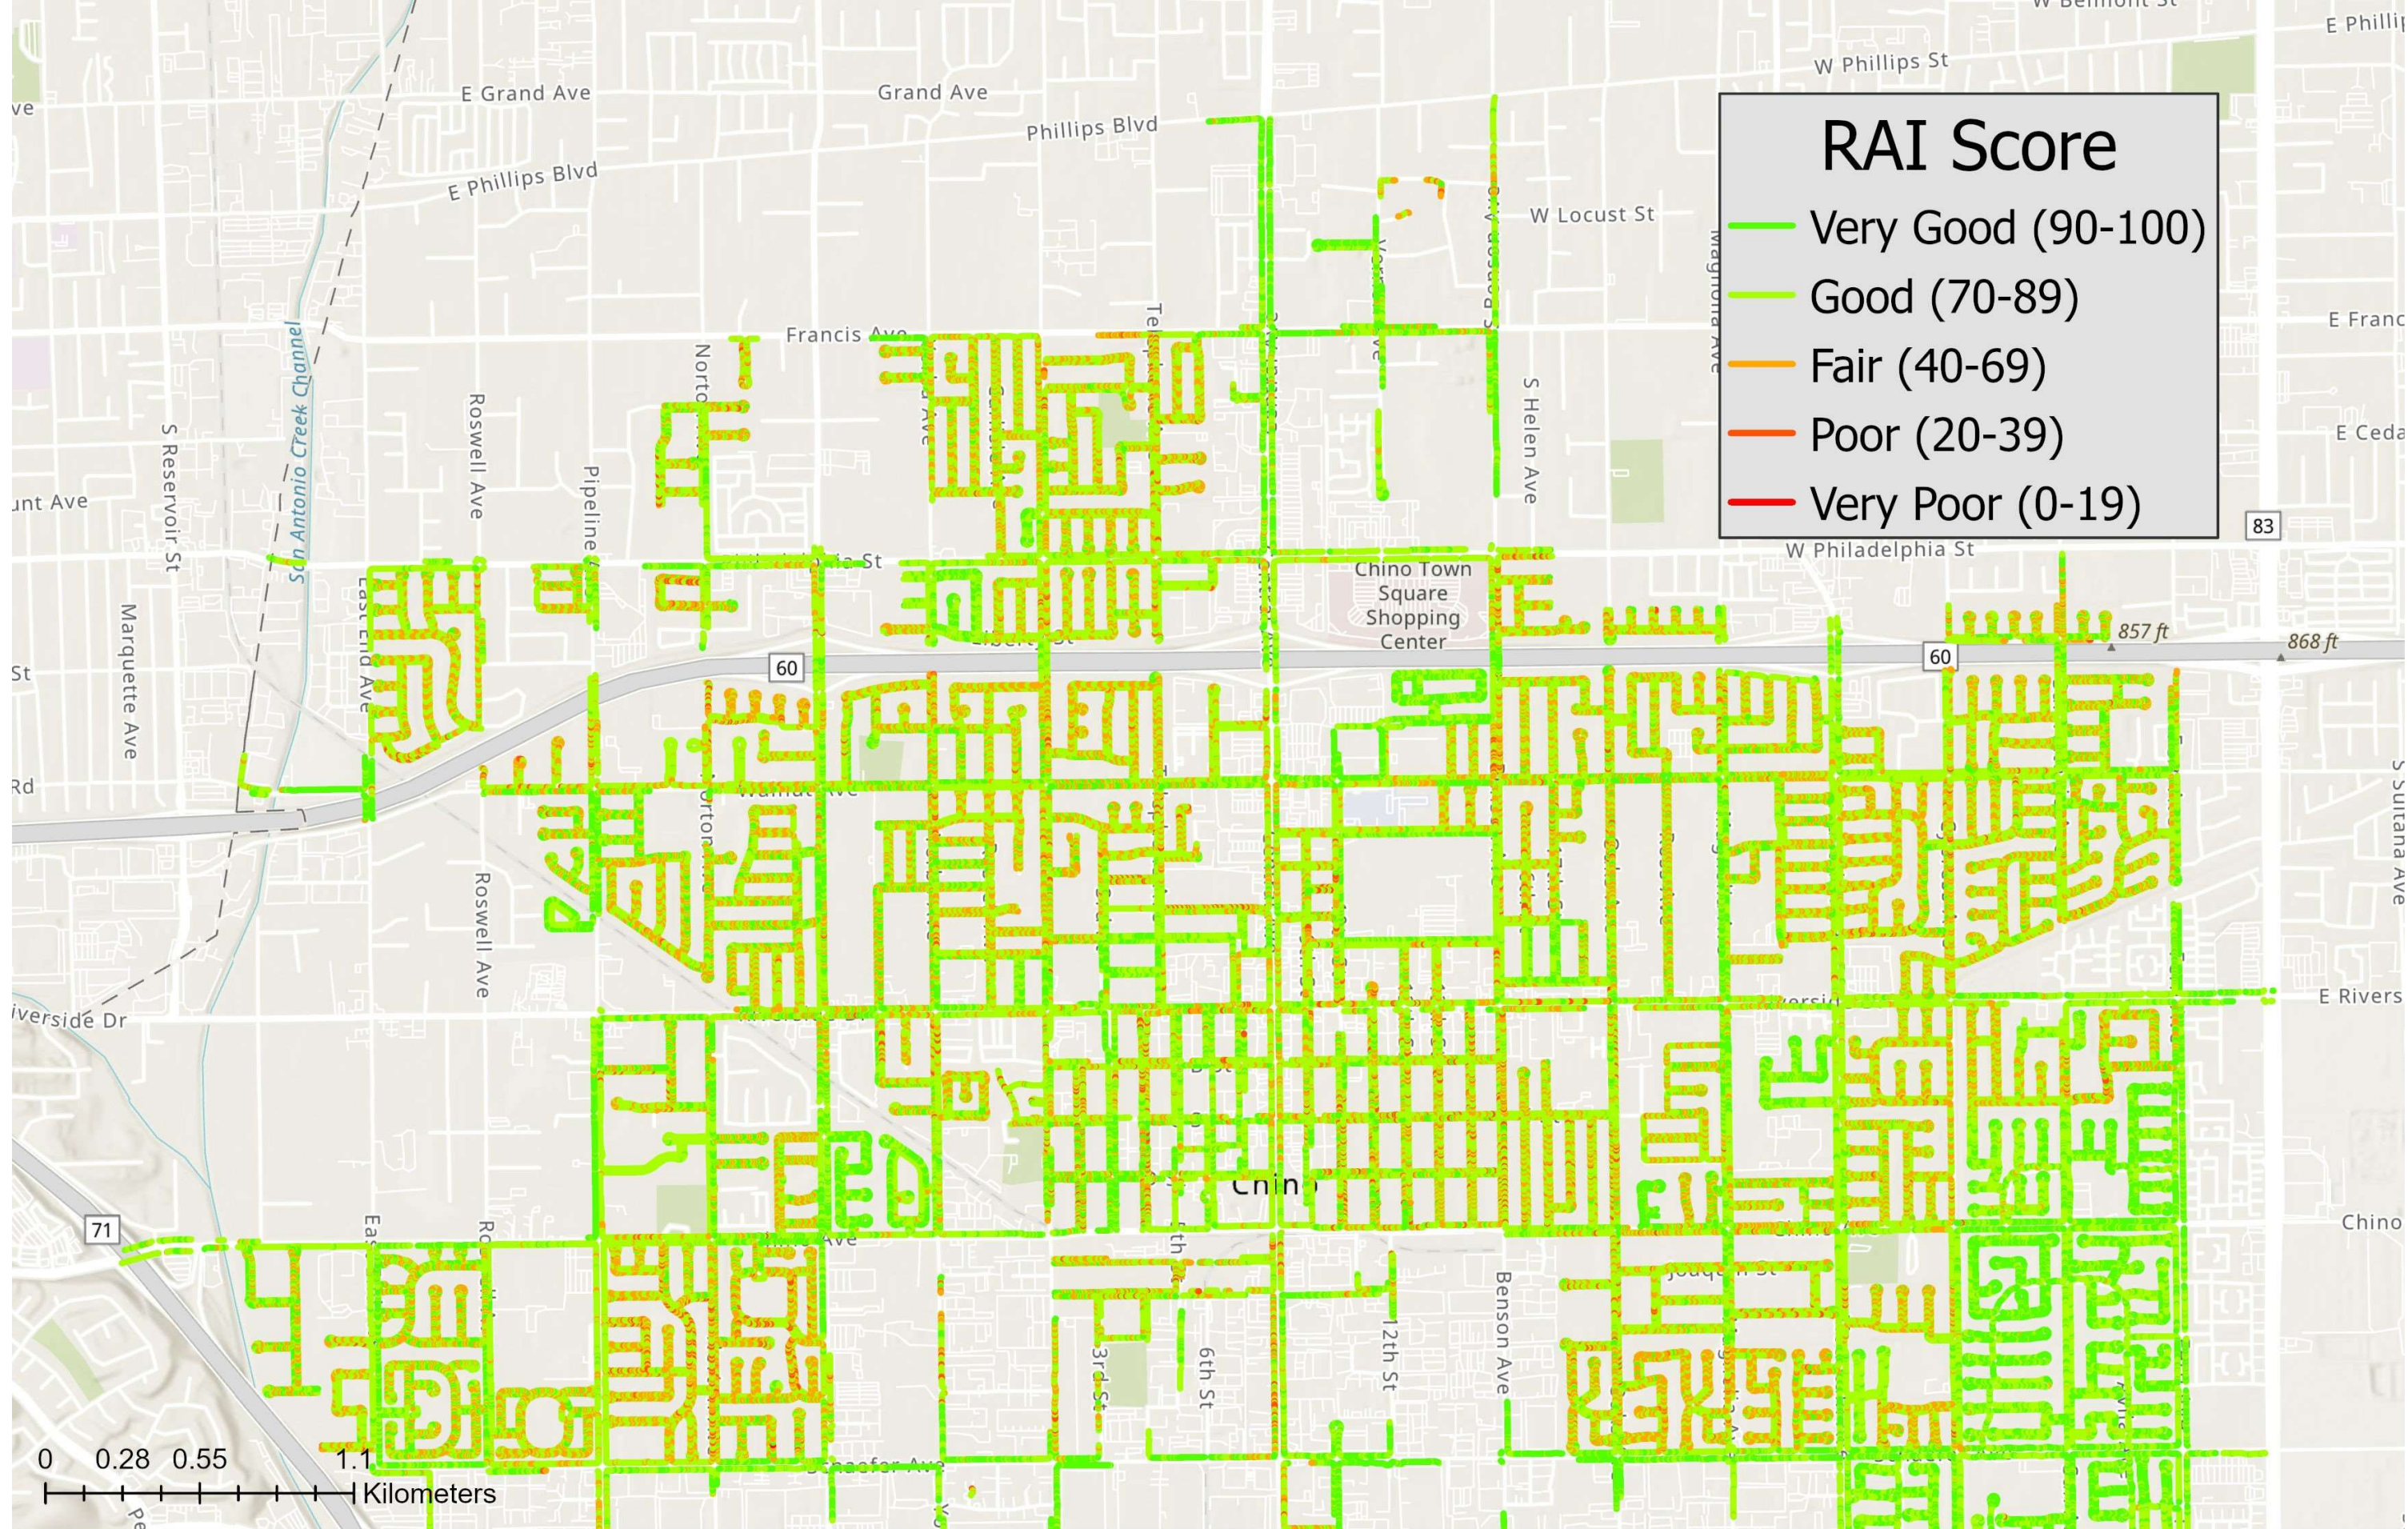
# Chino, CA Sidewalk Evaluation-North

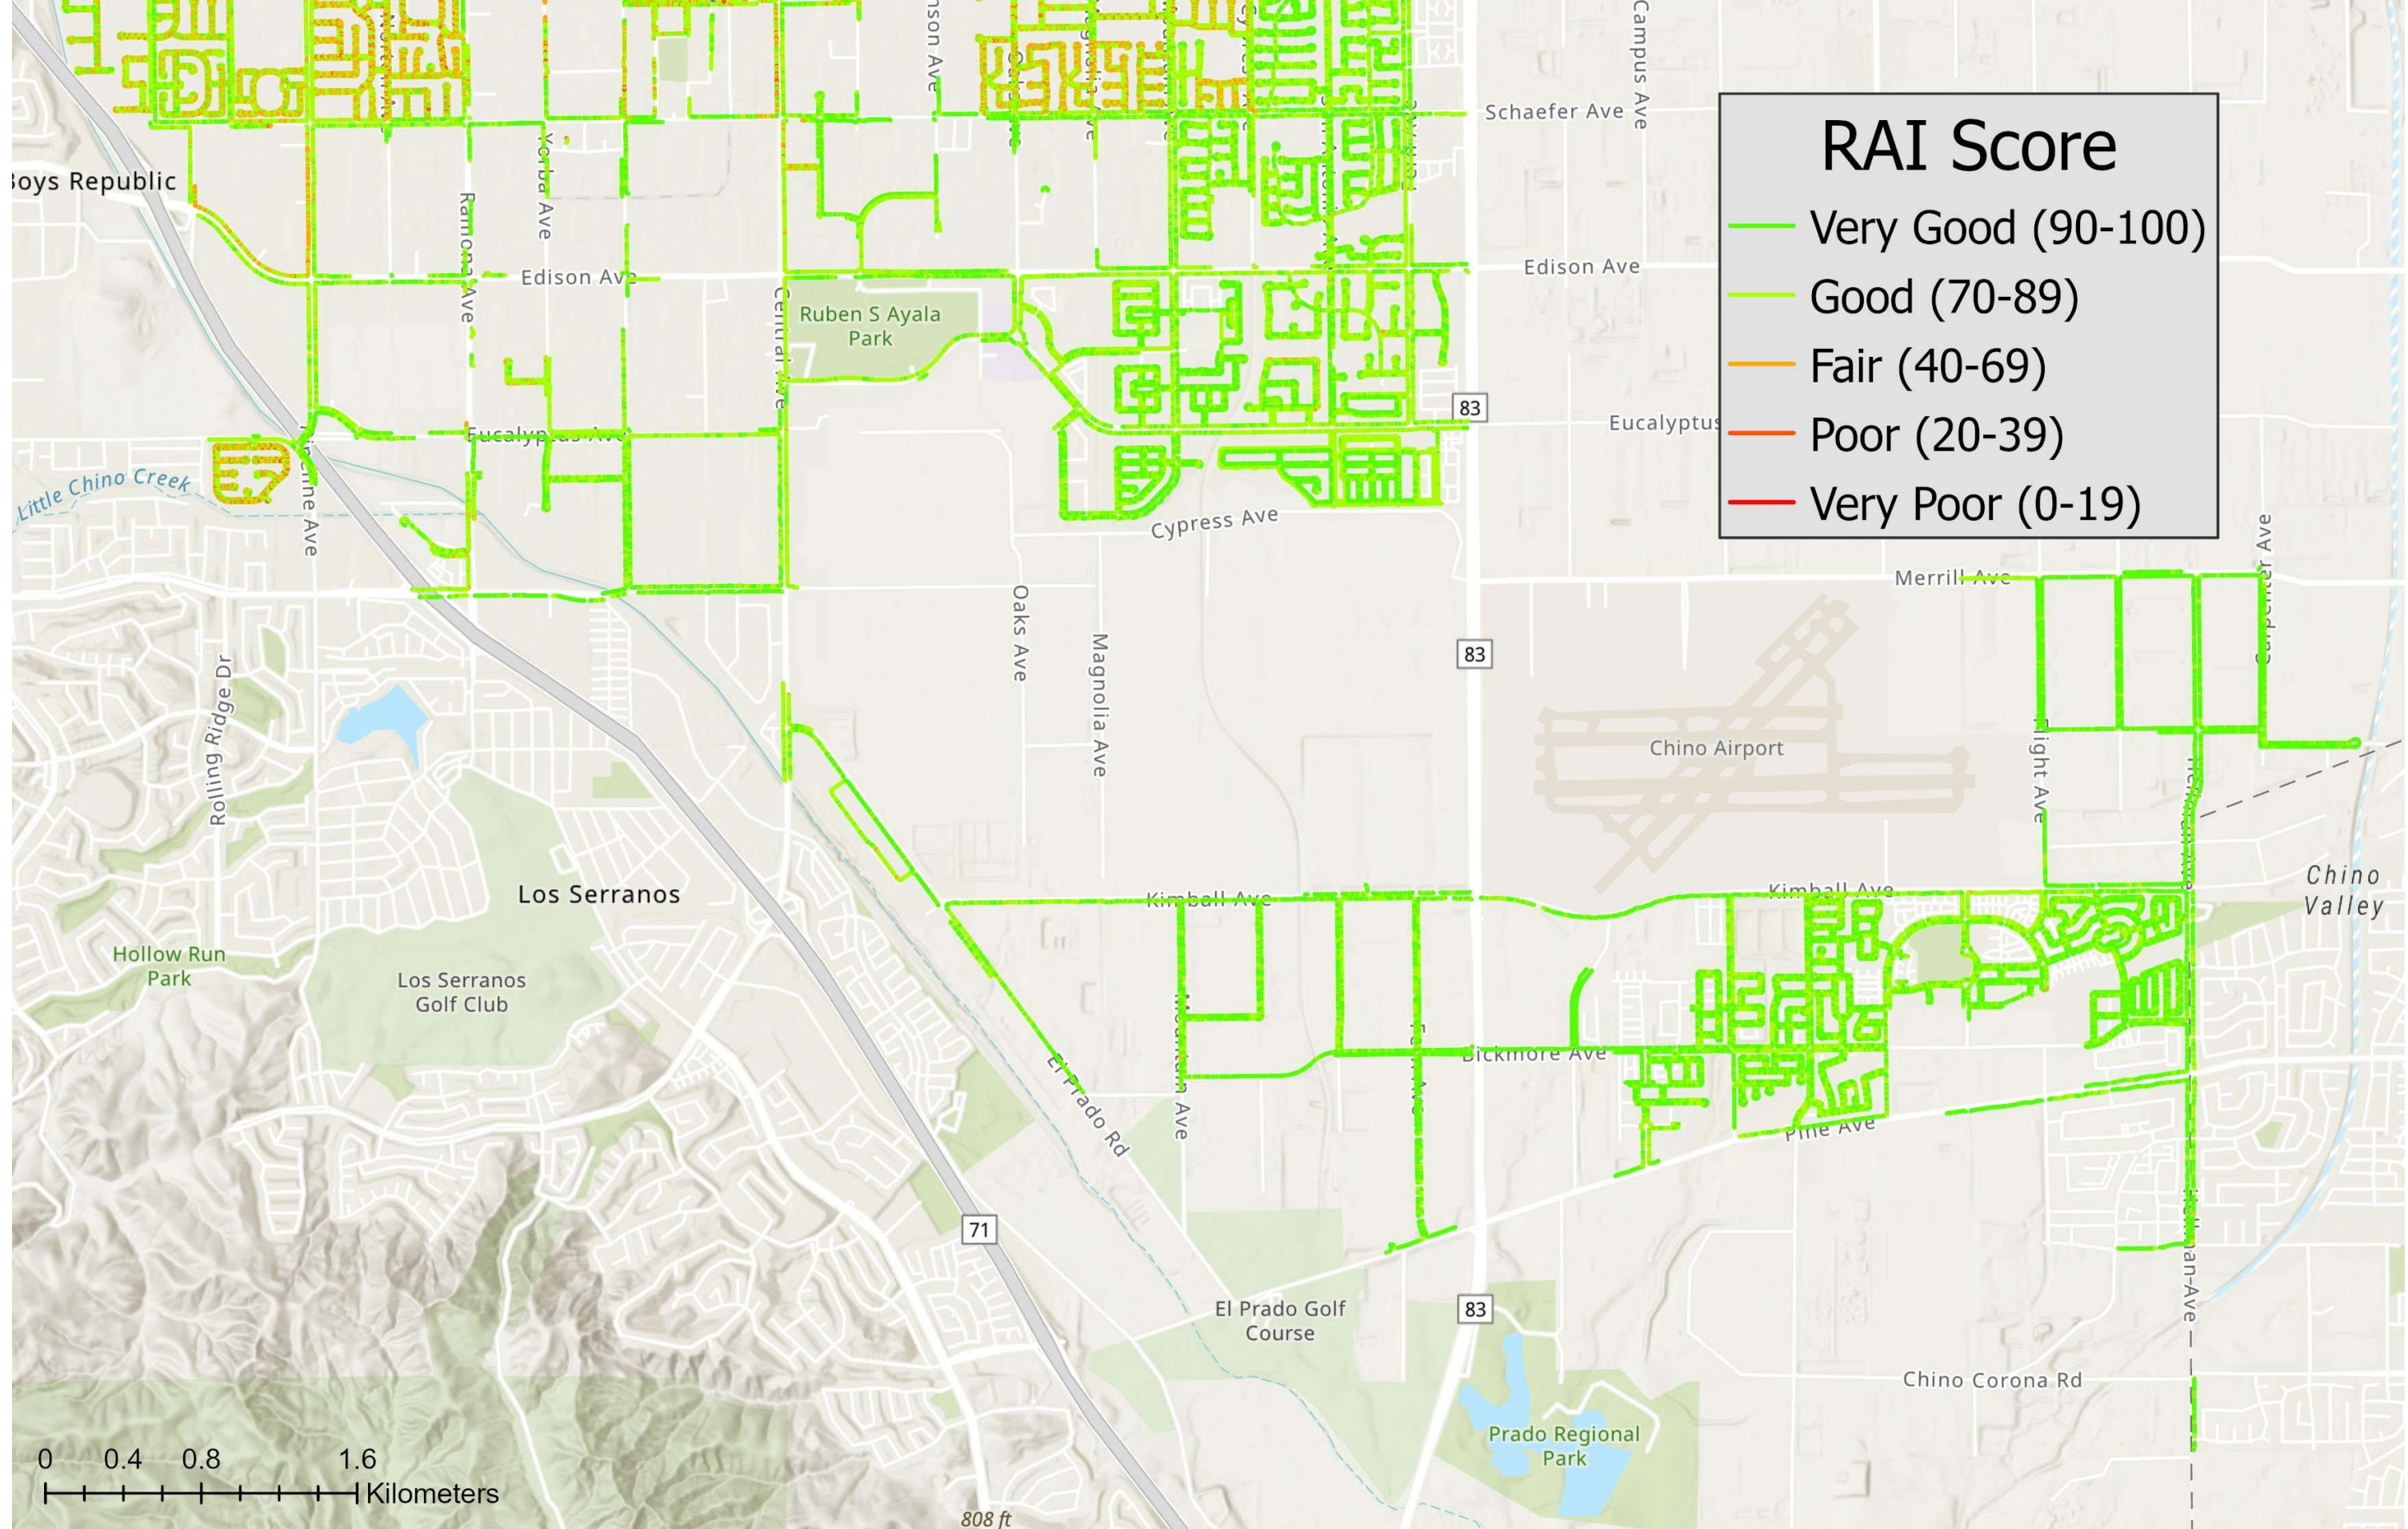
# Chino, CA Sidewalk Evaluation-South

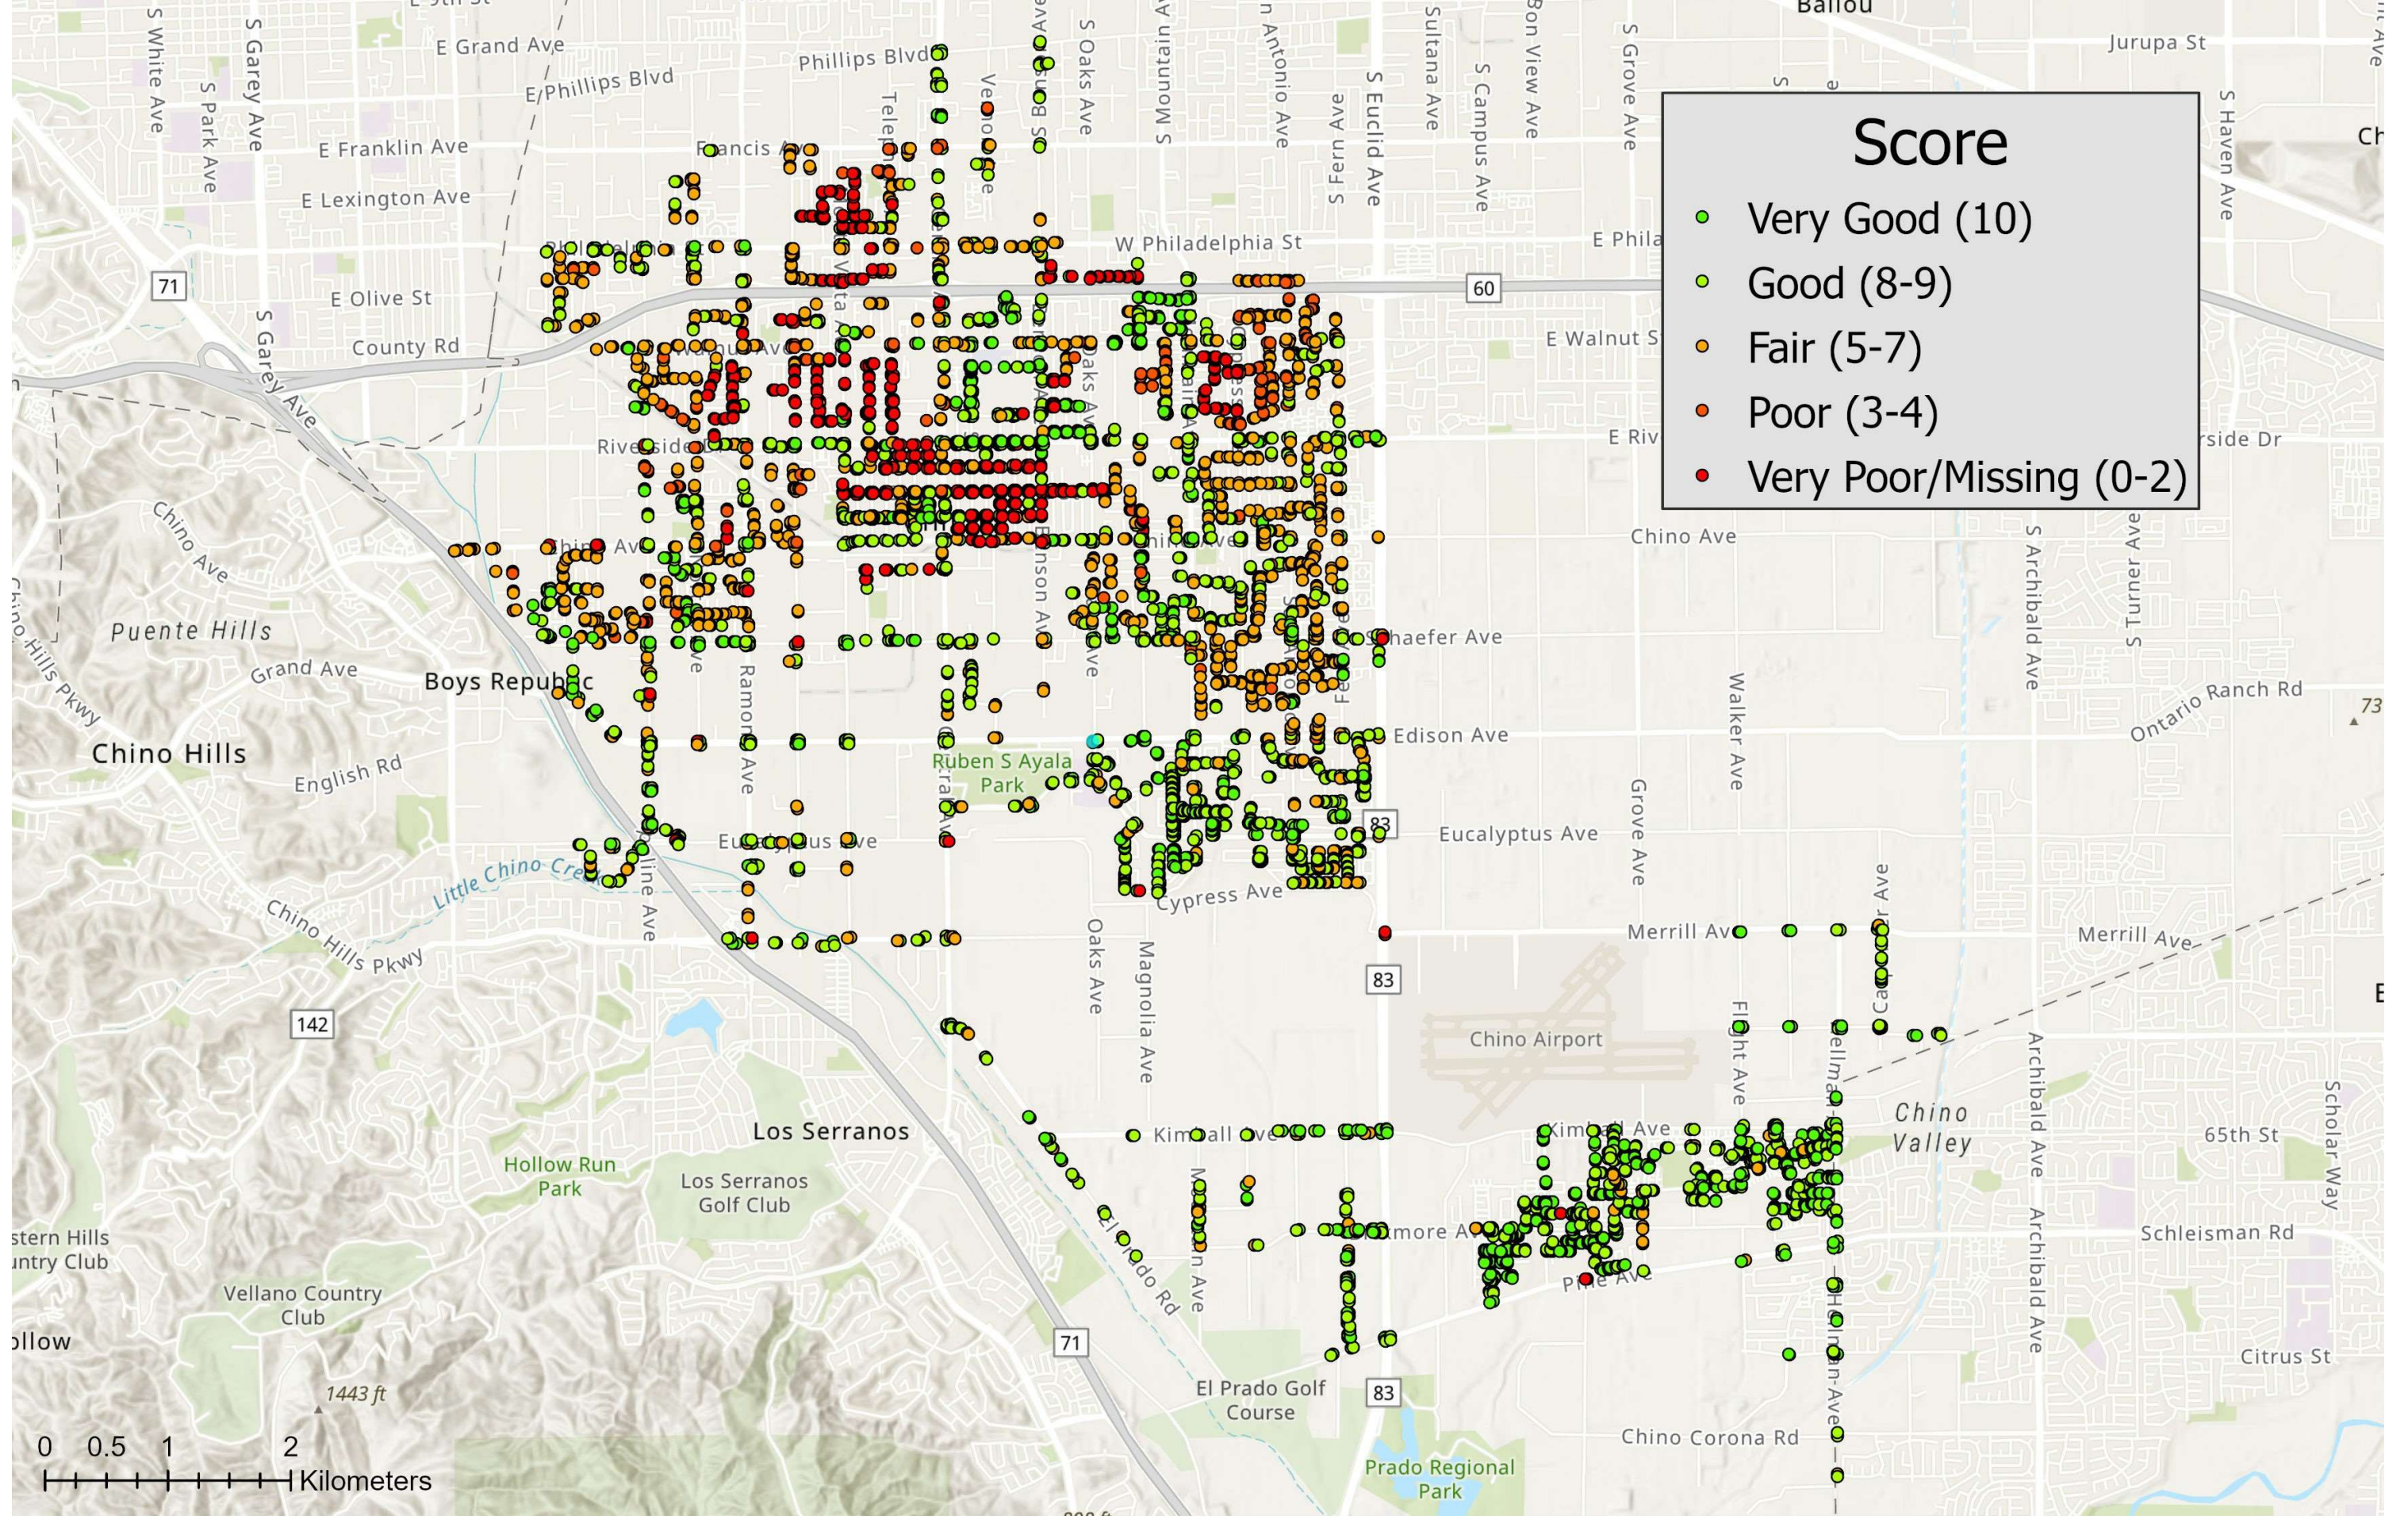
# Chino, CA Curb Ramp Evaluation
