# ADA TITLE II SELF-EVALUATION AND TRANSITION PLAN

## City of Chino

## ADA TITLE II SELF-EVALUATION AND TRANSITION PLAN

January 30, 2024

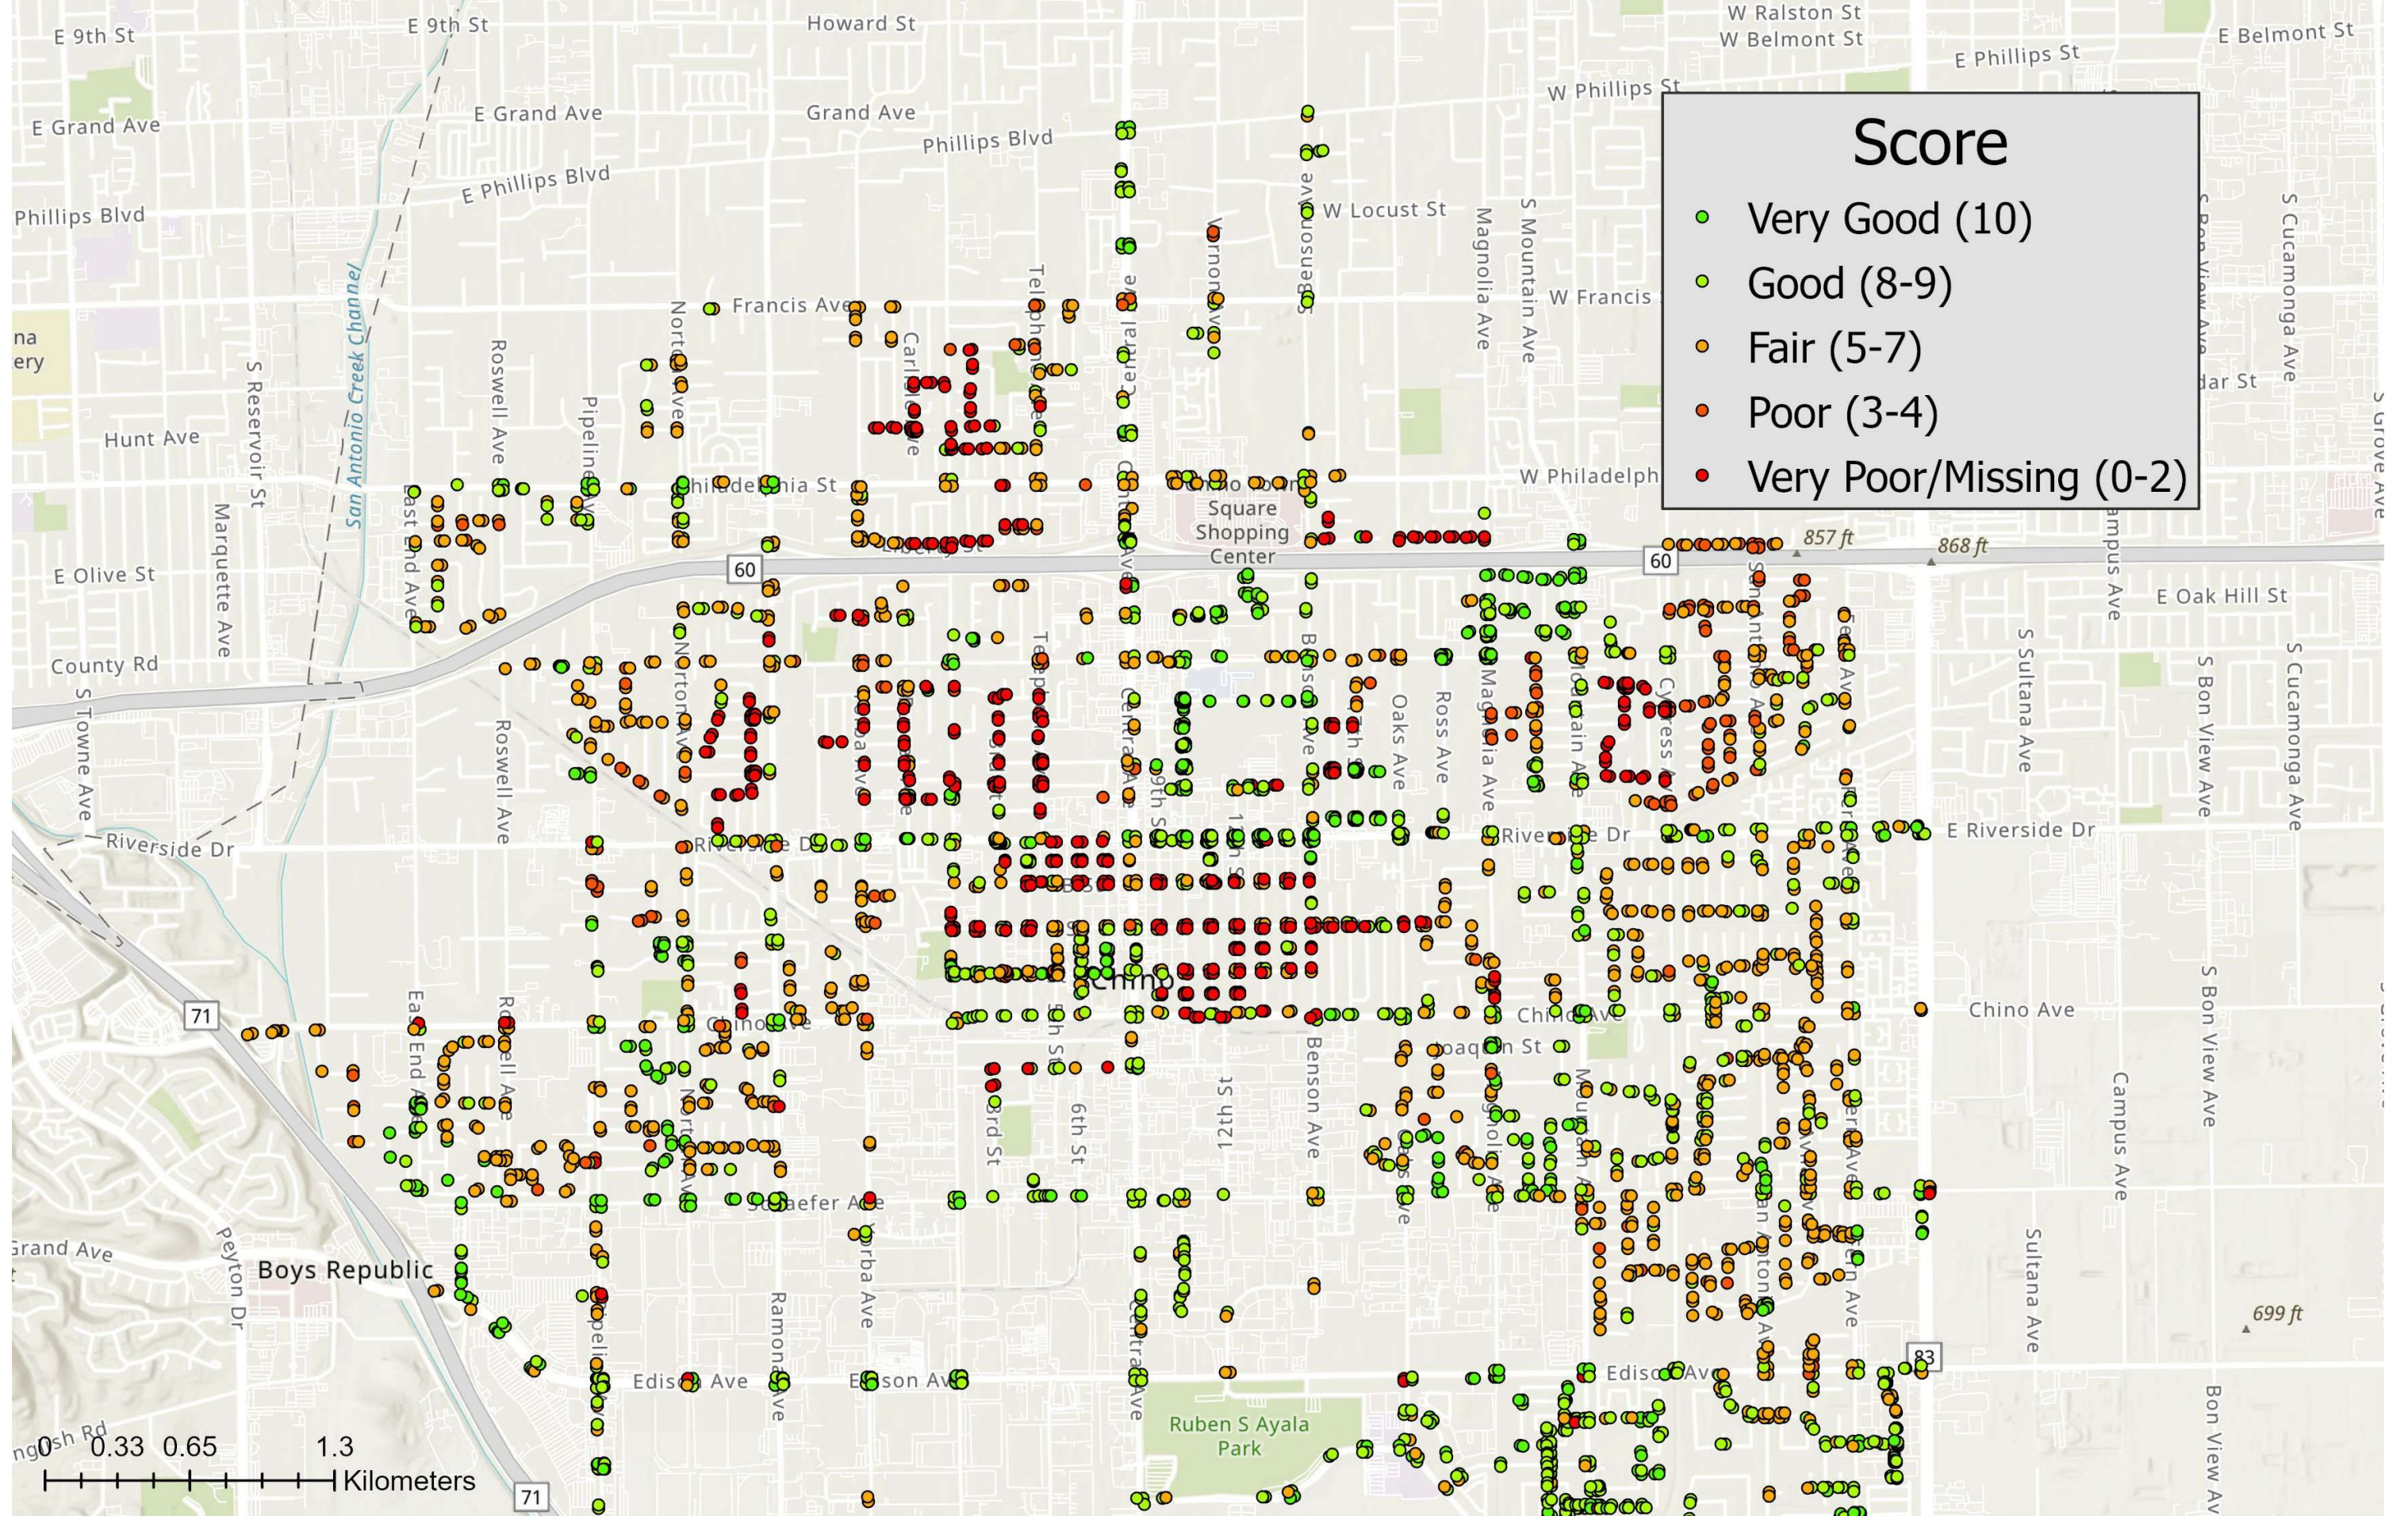
# Chino, CA Curb Ramp Evaluation-North

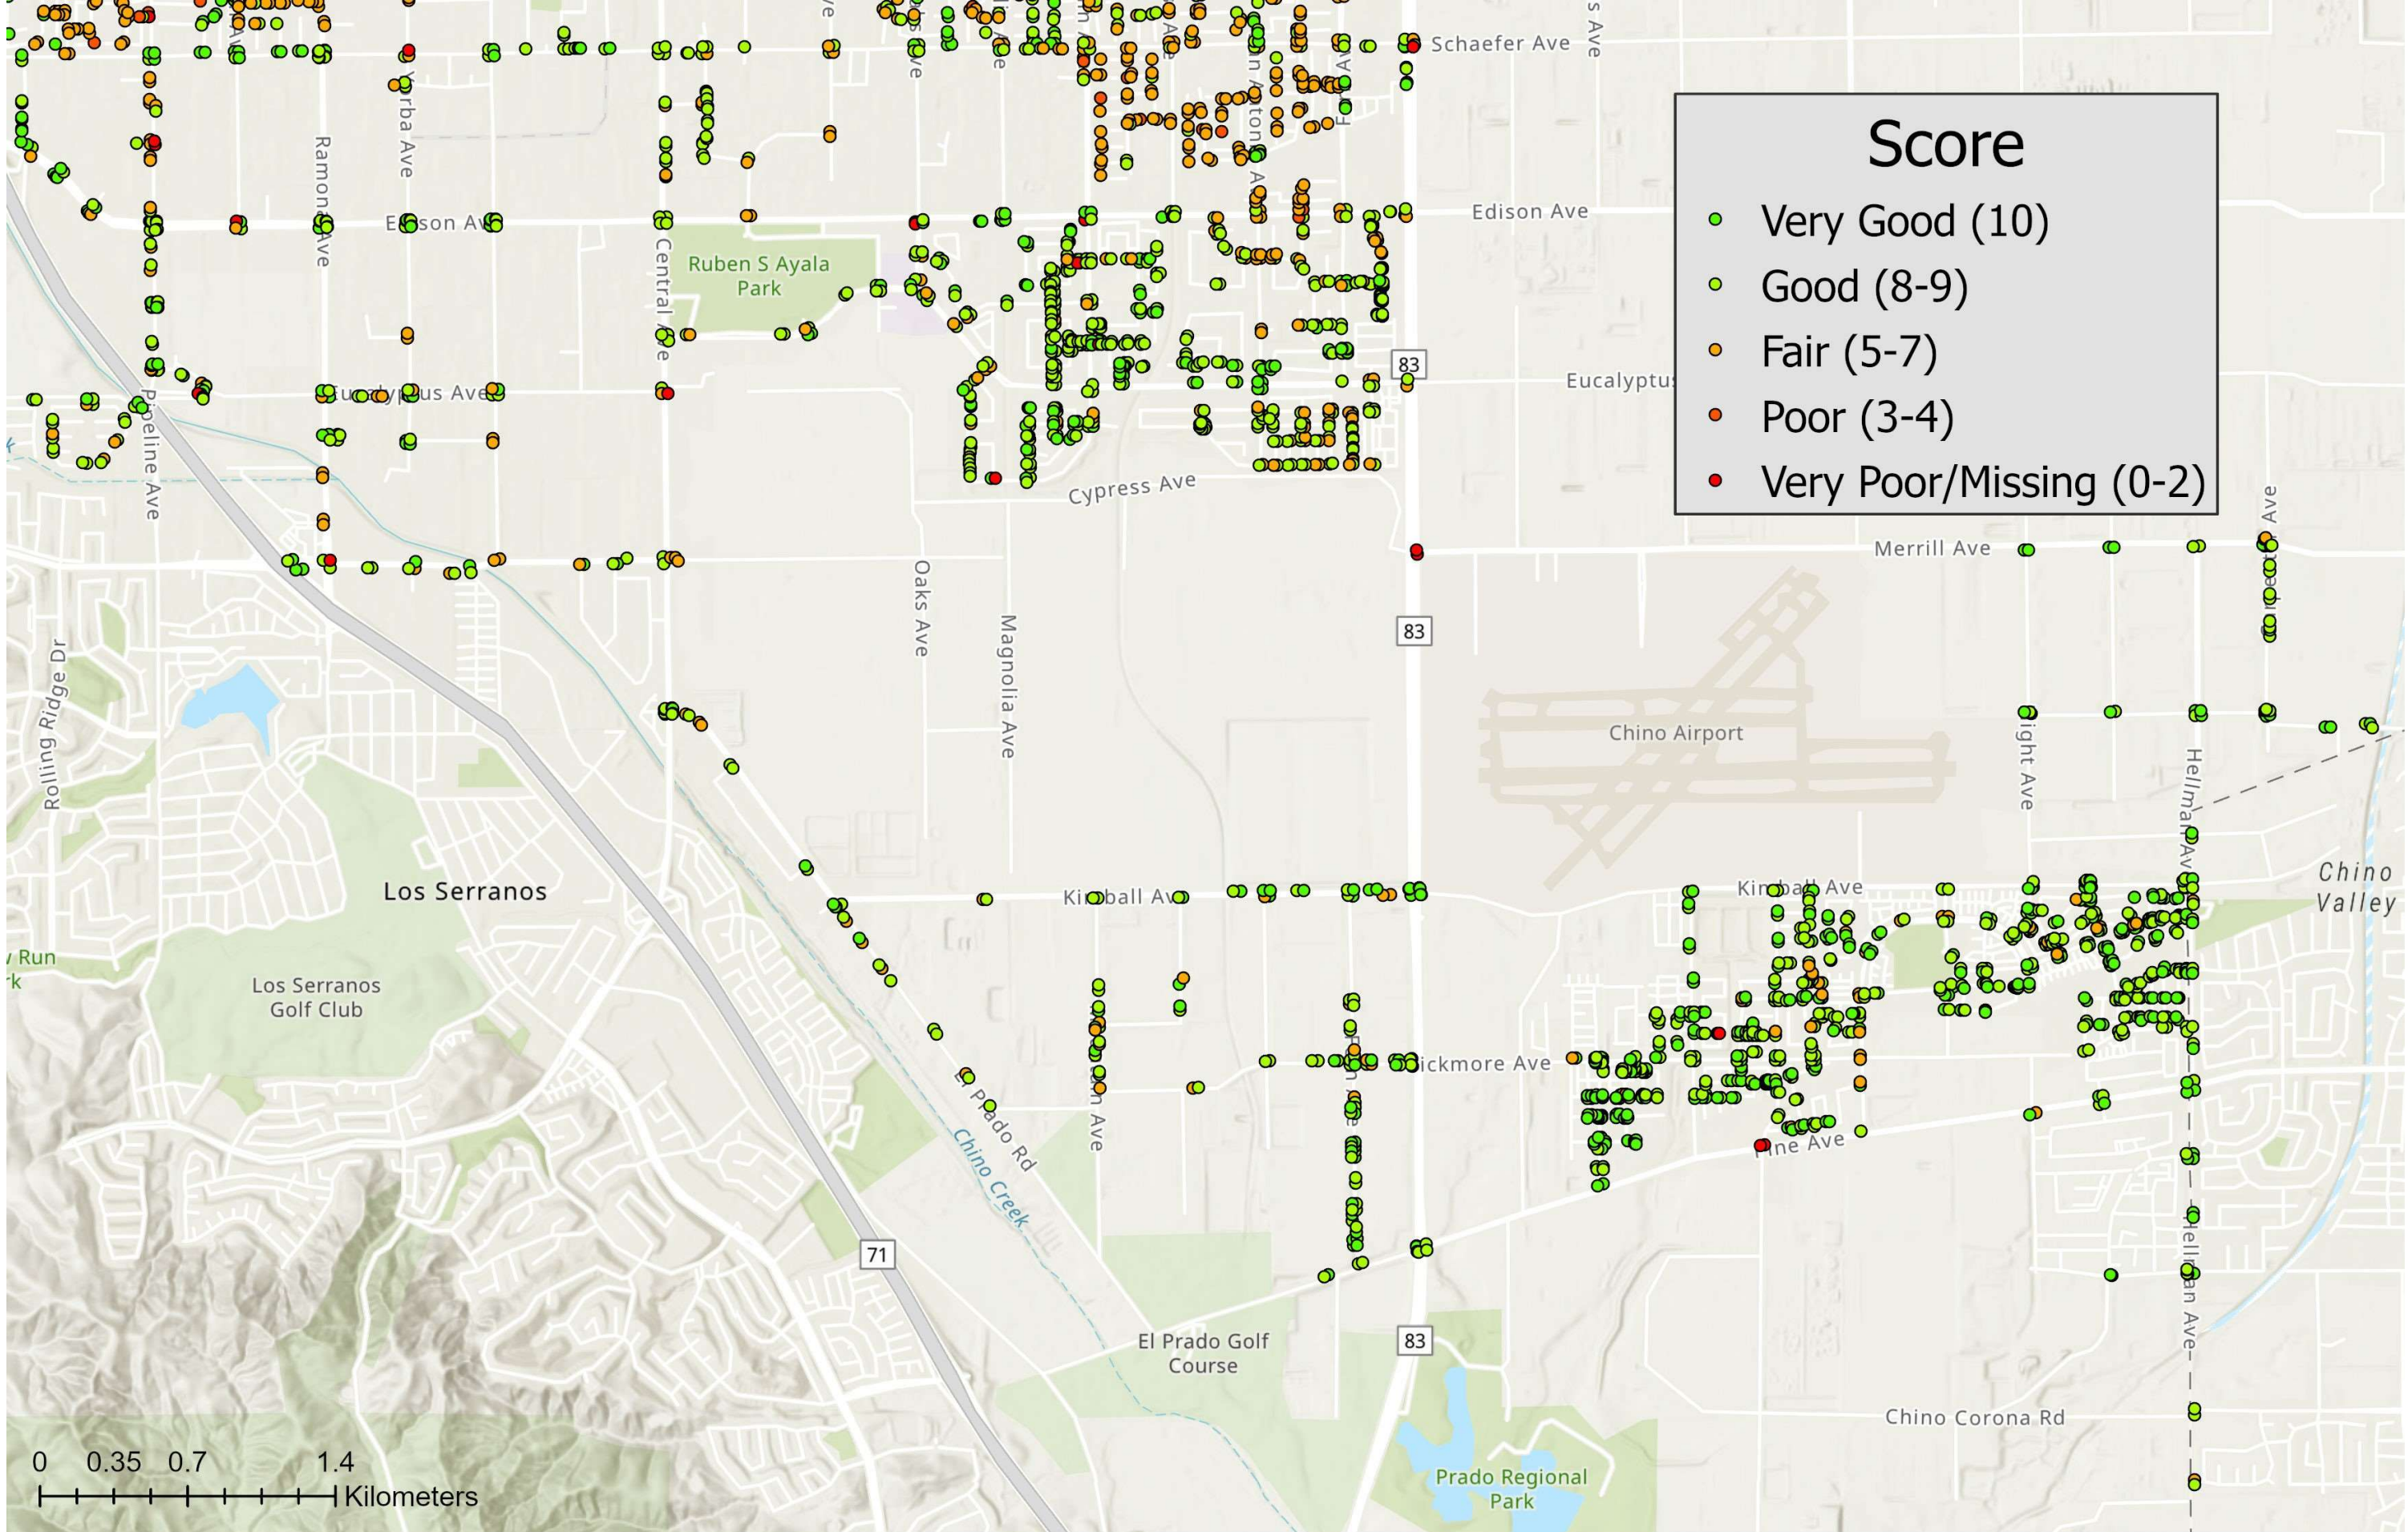
# 076 Chino, CA Curb Ramp Evaluation-South
